Positioned For Function: The Impact of the Appropriate Wheelchair on Occupational Performance

A Single Case Study

WFOT Congress 2018

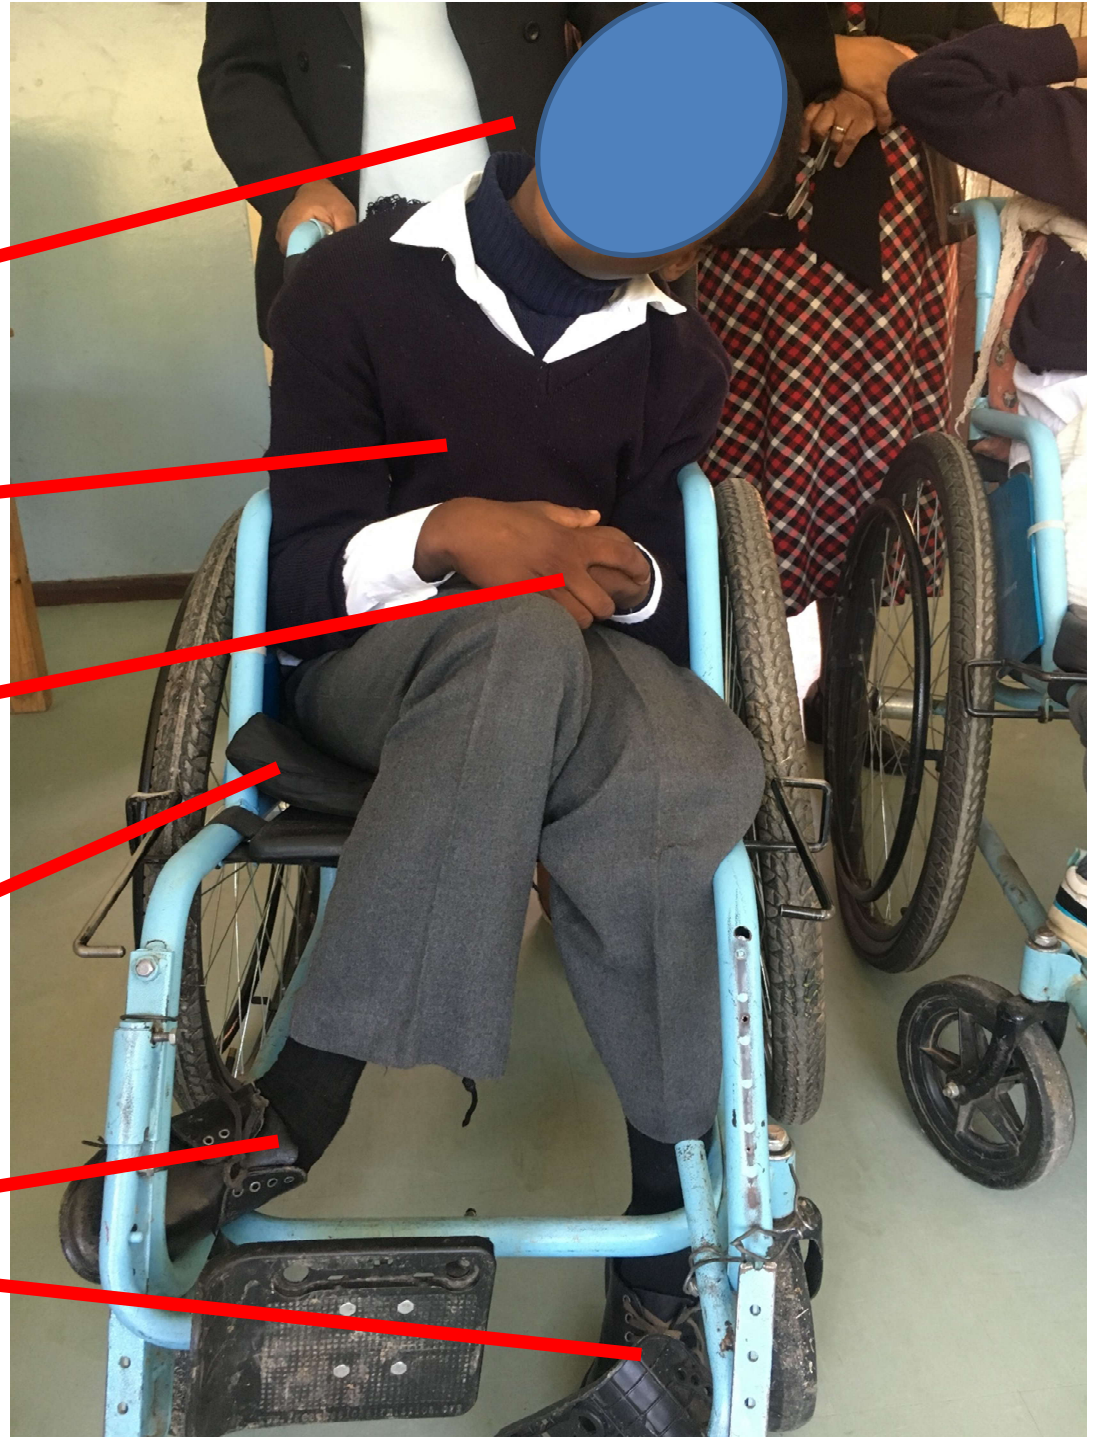
L.M. Existing Device

Head poorly positioned

Trunk not well supported

Limited use of upper limbs

Cushion too thin and
bottomed out

Fixating for stability

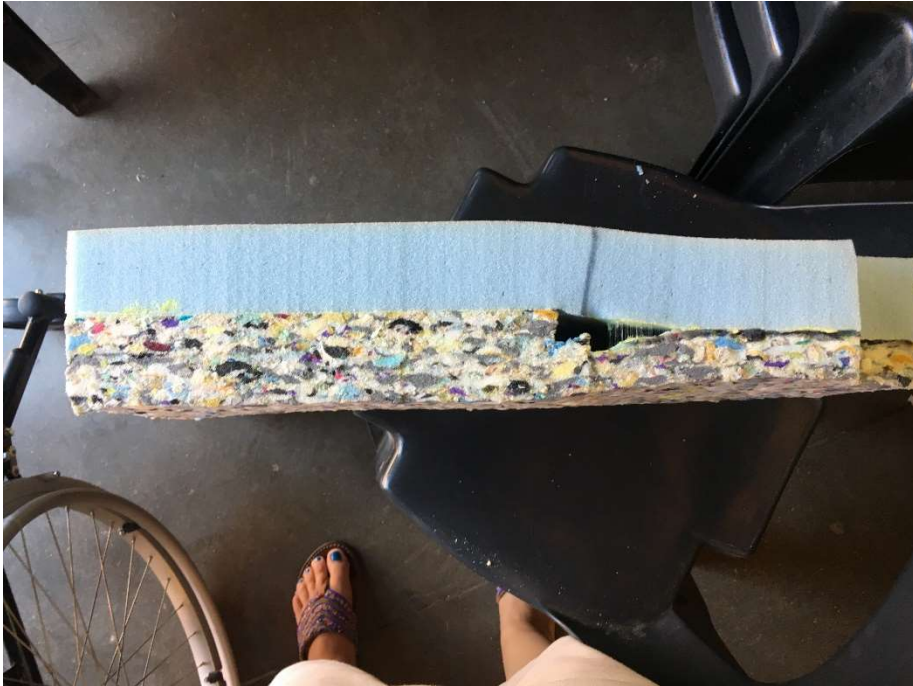
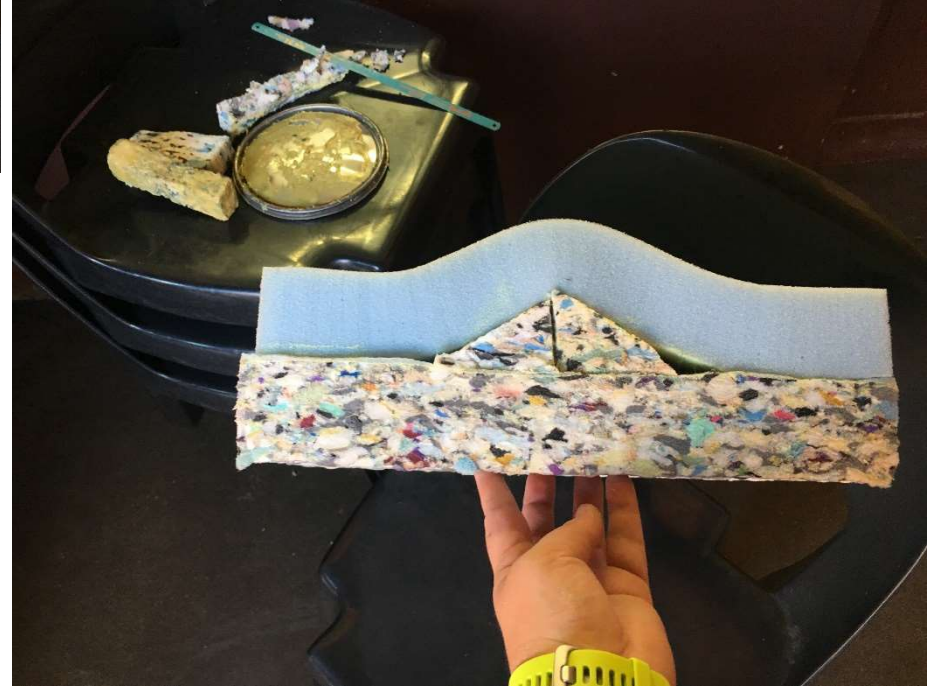
Intervention – cushion customisations

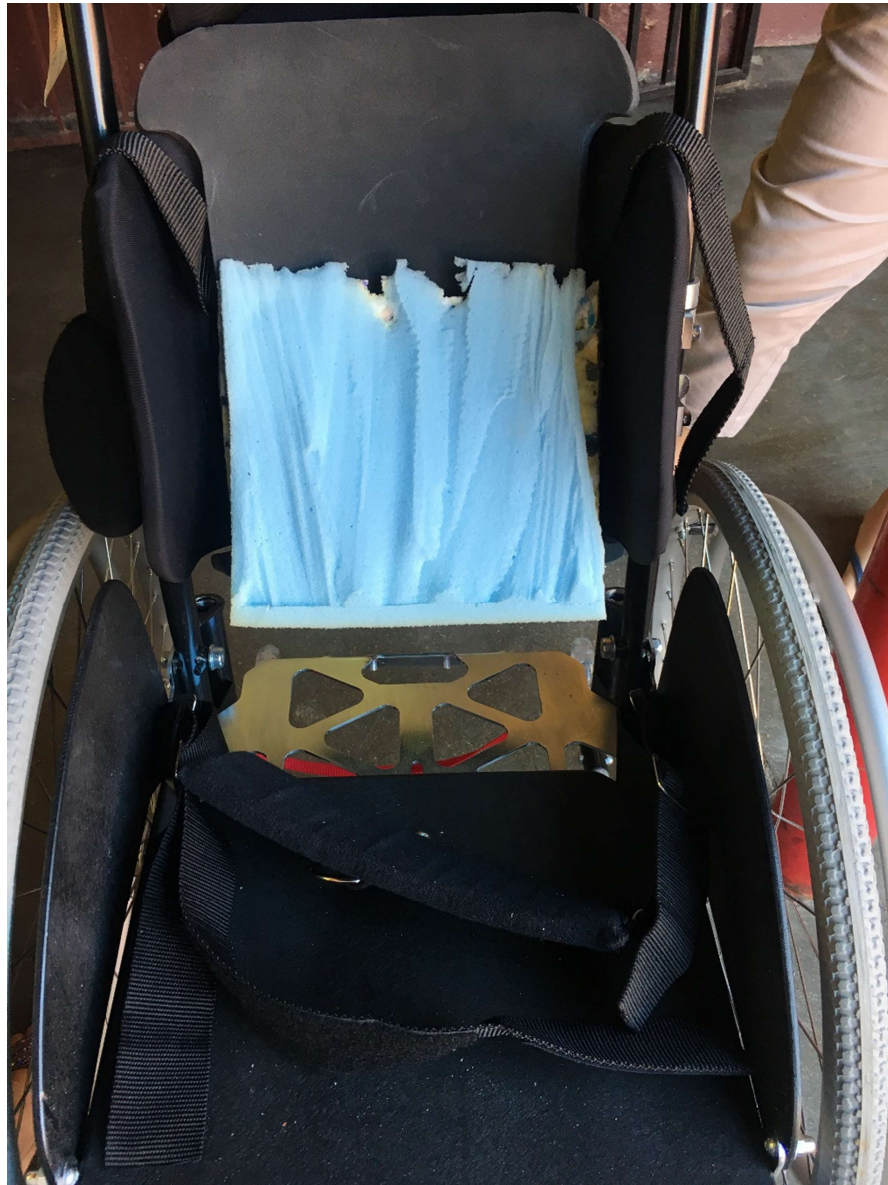
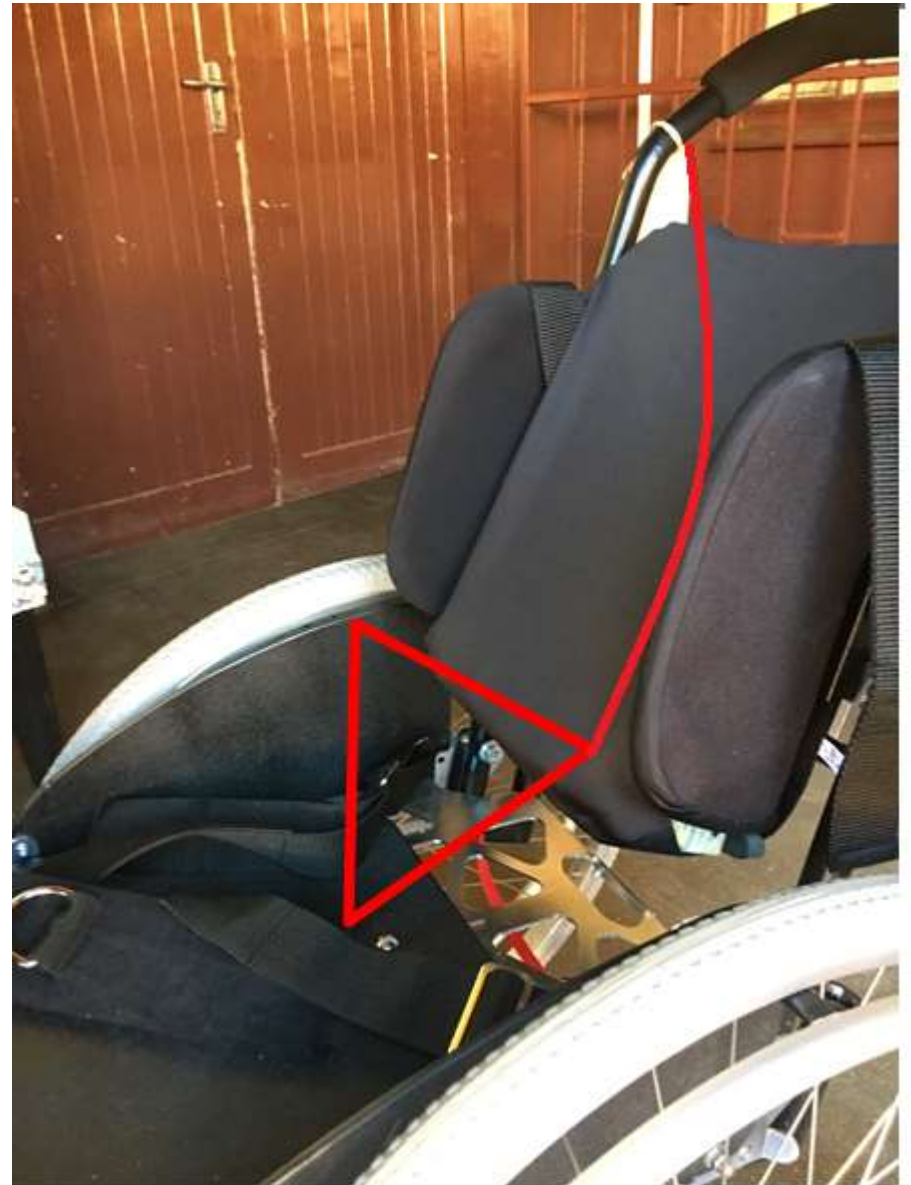
Intervention – open seat to back angle

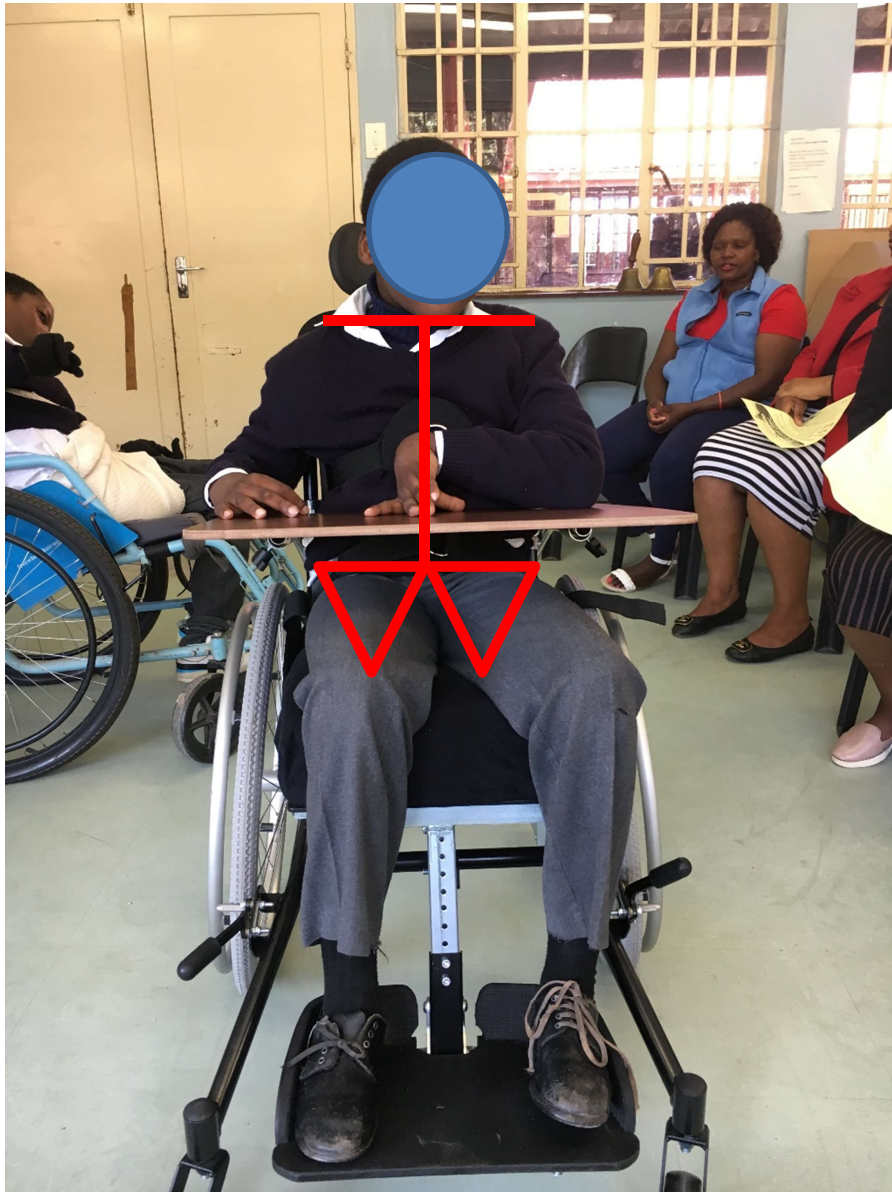
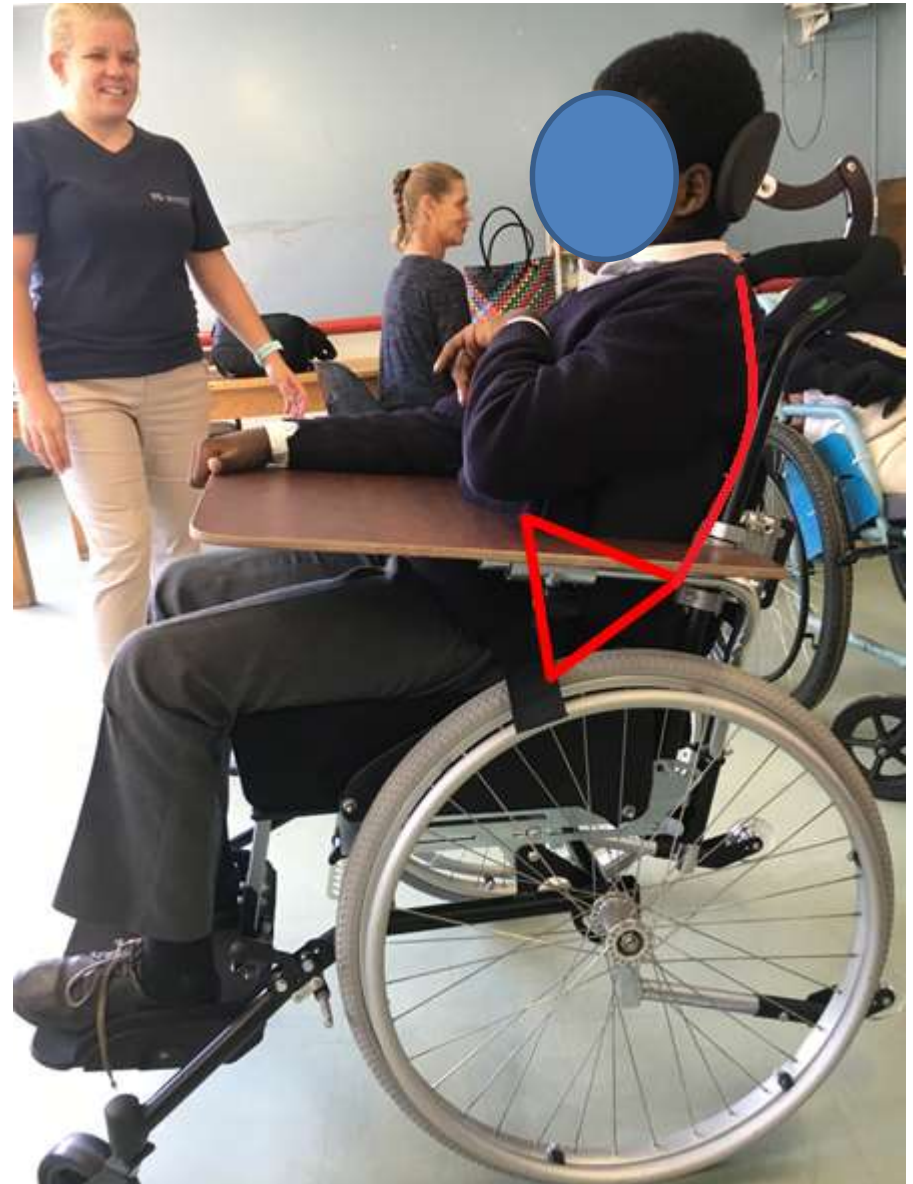
Final Posture

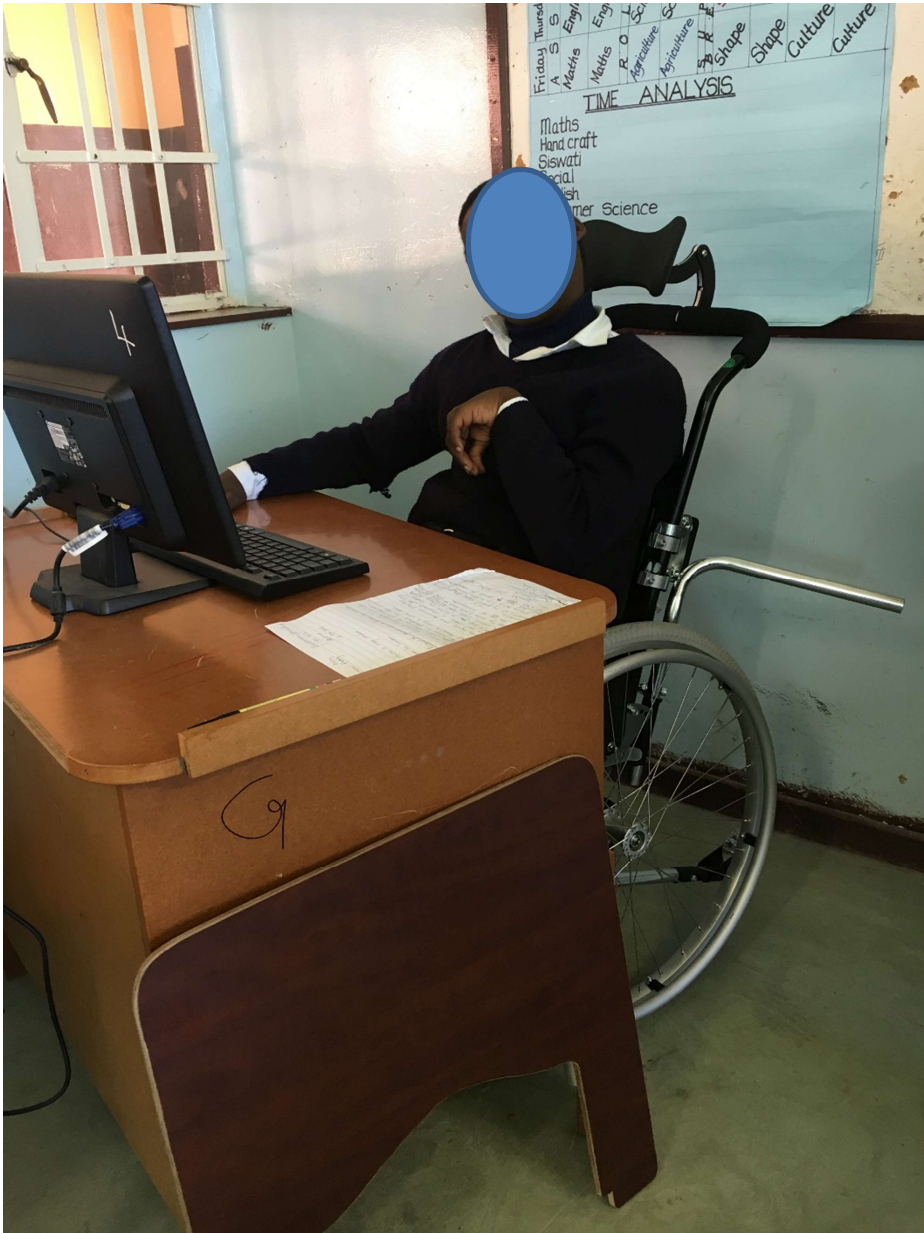
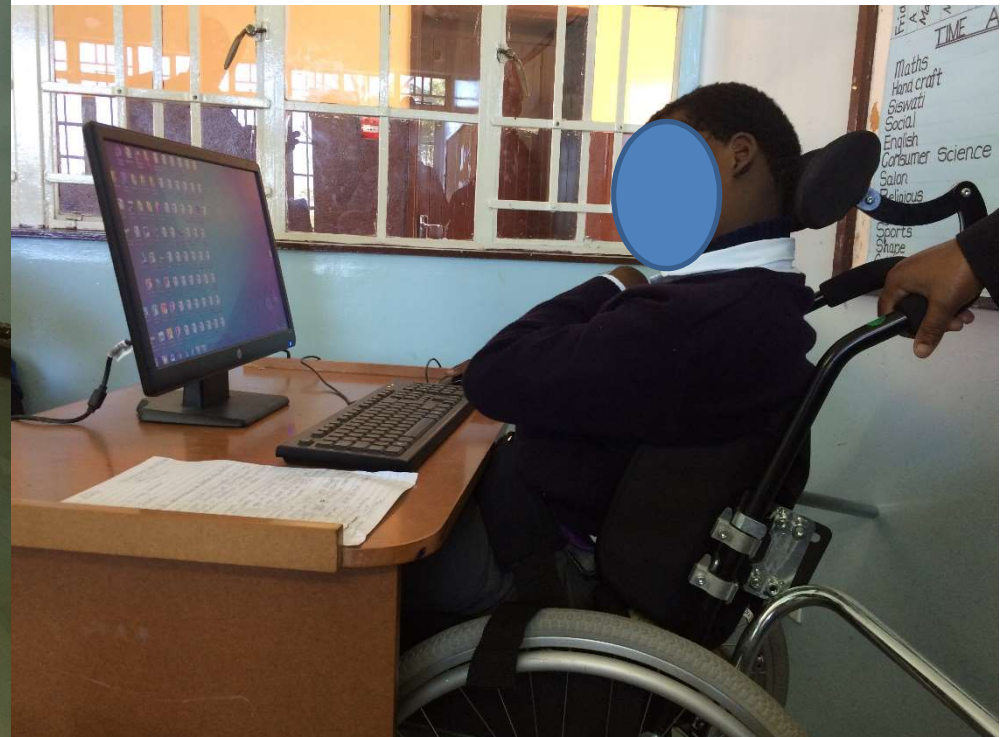
Outcome – better positioned for classroom activities
